**Rescue shaft 1**

**Rescue shaft 2**

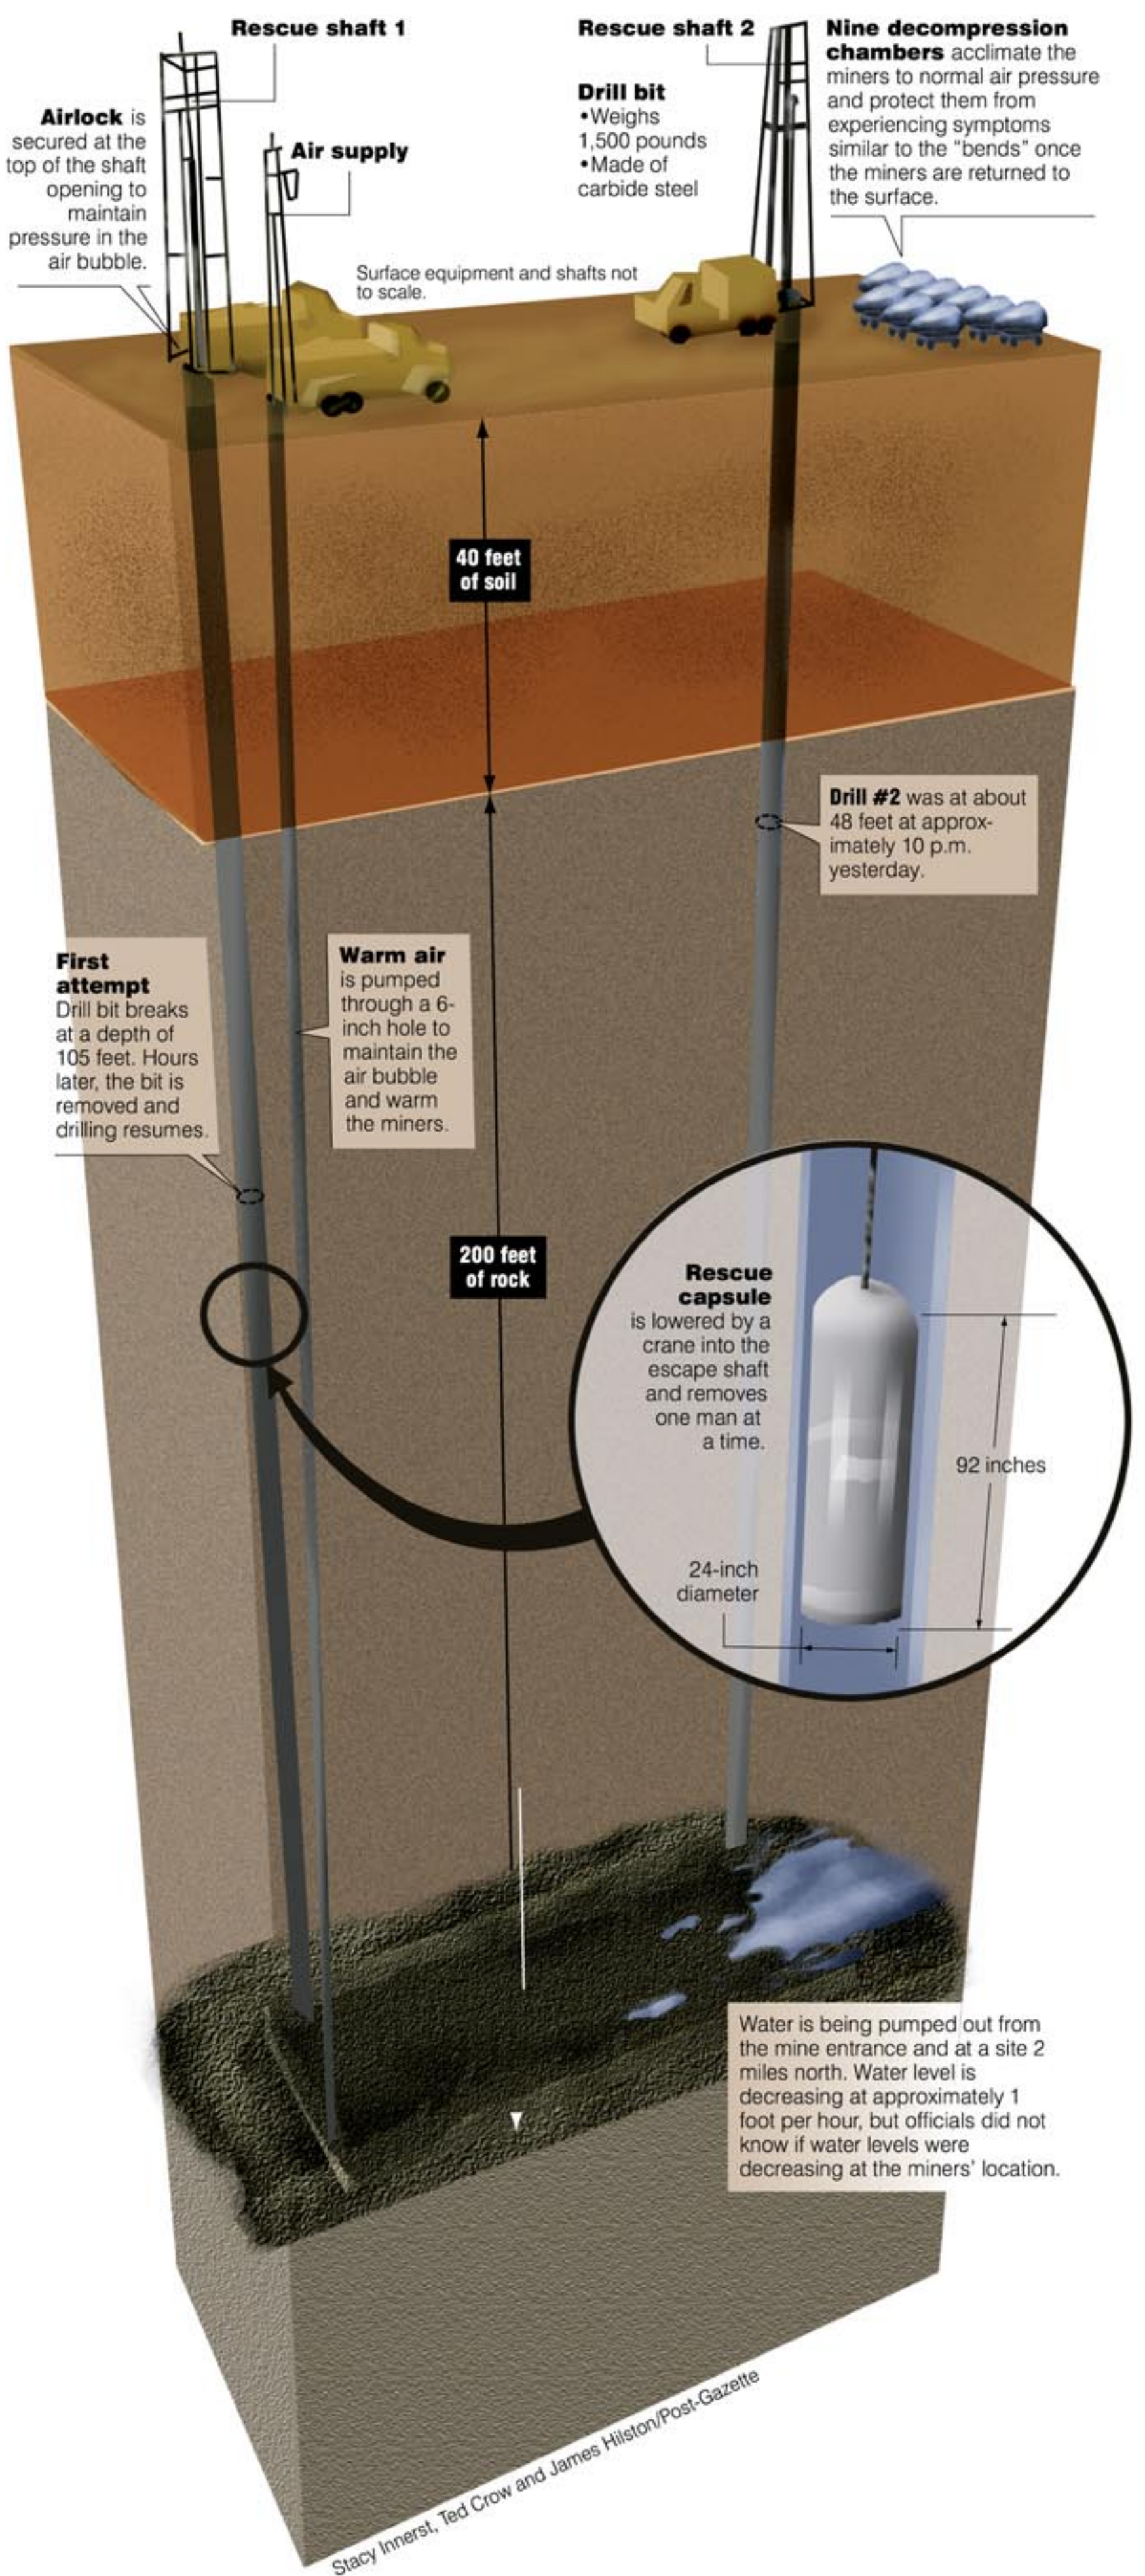
**Nine decompression chambers** acclimate the miners to normal air pressure and protect them from experiencing symptoms similar to the "bends" once the miners are returned to the surface.

**Airlock** is secured at the top of the shaft opening to maintain pressure in the air bubble.

**Drill bit**  
 •Weighs 1,500 pounds  
 •Made of carbide steel

**Drill #2** was at about 48 feet at approximately 10 p.m. yesterday.

**First attempt**  
 Drill bit breaks at a depth of 105 feet. Hours later, the bit is removed and drilling resumes.

**Warm air** is pumped through a 6-inch hole to maintain the air bubble and warm the miners.

**Rescue capsule** is lowered by a crane into the escape shaft and removes one man at a time.

Water is being pumped out from the mine entrance and at a site 2 miles north. Water level is decreasing at approximately 1 foot per hour, but officials did not know if water levels were decreasing at the miners' location.
